KMCO INC Update Crosby, Texas NRC # 1241683

April 2, 2019 1800

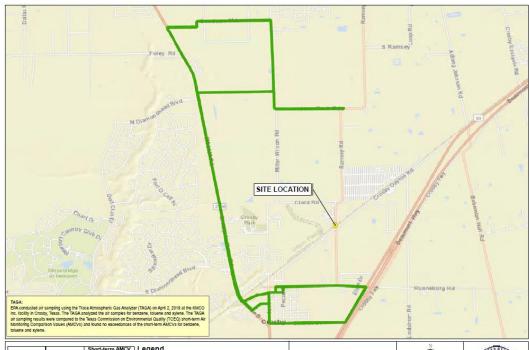
TAGA MONITORING MAP KMCO INC EXPLOSION 16503 RAMSEY RD CROSBY, HARRIS COUNTY, TEXAS

- The Trace Atmospheric Gas Analyzer (TAGA) mobile laboratory began mobile monitoring in the surrounding area and has not detected any readings above the short term TCEQ AMCVs.

SITE LOCATION RESULTS BELOW AMCVs

REPORTING PERIOD #01 4/2/2019 1200 - 4/2/2019 1630
